NSWCCD-TR-97/014

Business Directorate  
Technical Report

## **Lead Corrosion in Exhibition Ship Models**

by  
Dana Wegner,  
Curator of Models

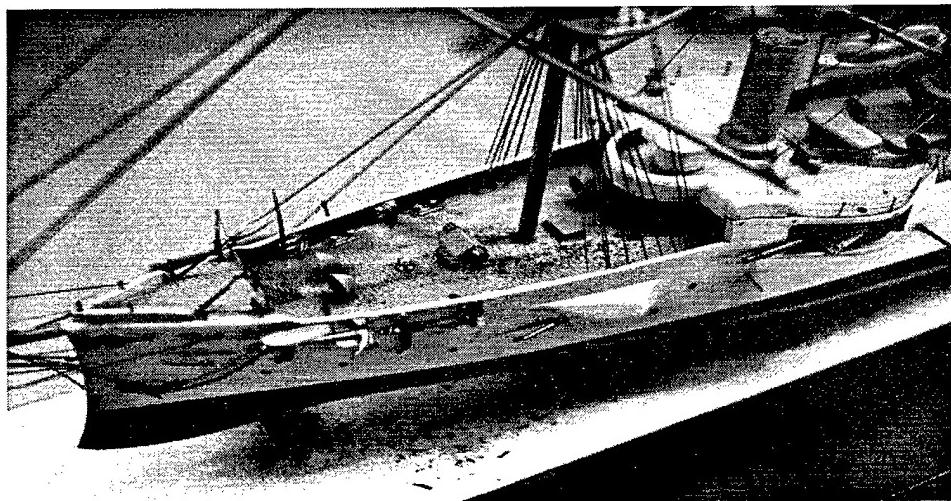
Figure 1. USS *Chicago*

Note: Department of the Navy model catalog #181. Scale 1:96. Built by the Boucher Company, 1922. Photograph taken February 1996 showing advanced state of lead corrosion accrued since 1974. Here, some, but not all, of the lead bitts and ventilators have corroded and littered the forward deck with a gray corrosion byproduct. Portions of the port side anchor have also corroded despite a coating of black paint. Between 1934 and 1994 this model was displayed in a large plywood and plexiglass display case containing a number of other models. Some of the other models showed similar signs of deterioration. NSWCCD Curator's Office photo, Michael Condon.

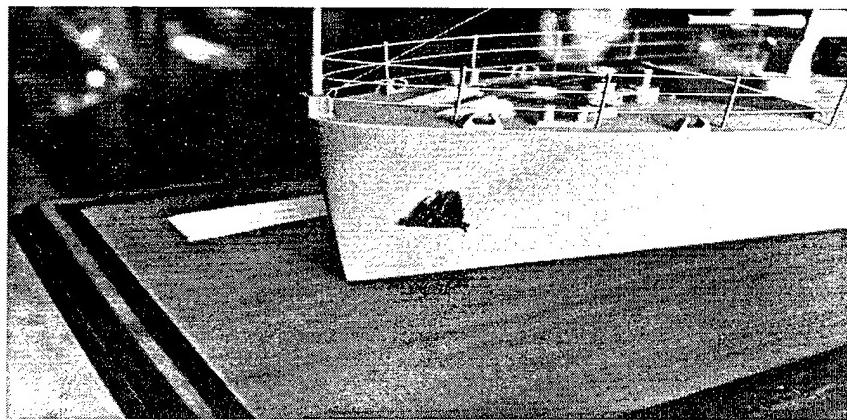
**Figure 2. USS PC-461**

**Note:** Navy Department Ship model catalog #587. Scale 1:48. Upgraded drawing room model by the Bureau of Ships, USN, ca. 1940. Photograph taken March 1997. The anchors, the only lead fittings on this model, have been a recurring source of corrosion problems since 1963 when the model was mounted in a glass display case with a mahogany base finished with Fabulon clear coat. The anchor previously had been cleaned and repainted in September 1978. NSWCCD Curator's Office photo, Michael Condon.

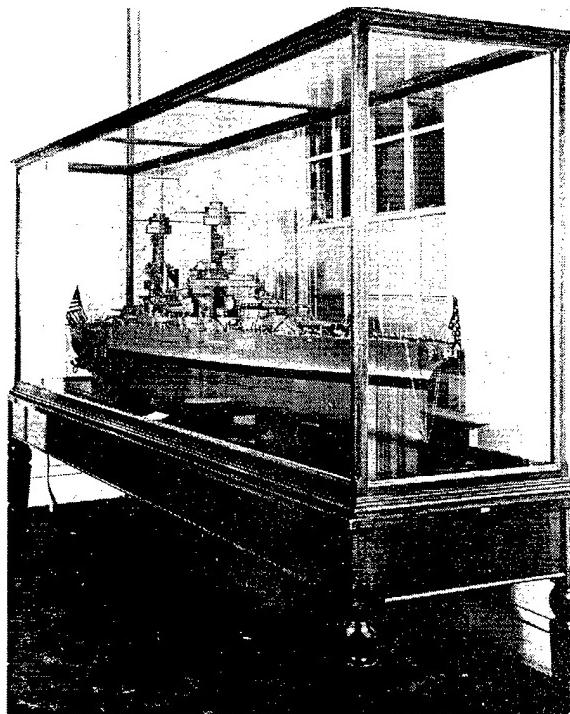
**Figure 3. USS California (BB-44)**

**Note:** Navy Department Ship model catalog #151. Scale 1:48. "Builder's model" by the Mare Island Naval Shipyard, ca. 1918. Resplendent in its beautiful contemporary mahogany and glass exhibit case, models such as these did not employ much lead in their construction. They present modern conservators with few lead-related problems. Perhaps the greatest lead-related conservation problem to be expected here is lead-bearing solder which might have been used for attaching parts together. The large glass plates of the exhibit case are set in a rabbet and simply are held in place with slim mahogany strip moldings. This relatively loose-fitted construction doubtless allows the air within the exhibit case to exchange at least once or twice a day, while still protecting the model from most dust and buffering the model from abrupt changes in temperature and humidity. NSWCCD Curator's Office photo.

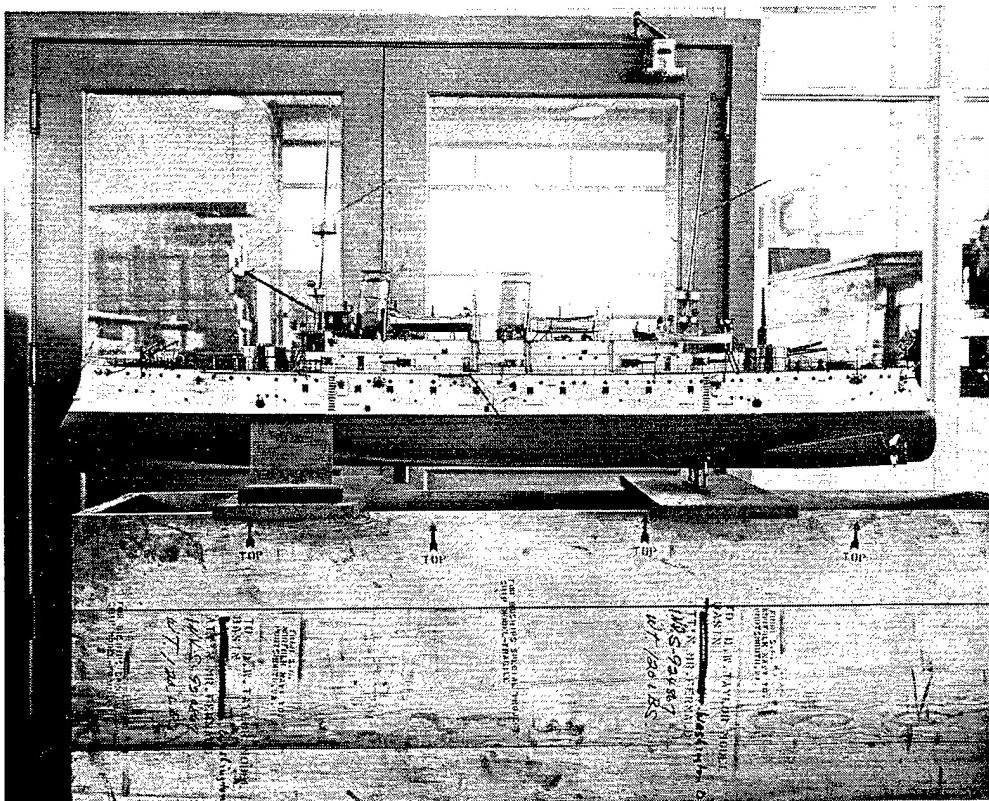
**Figure 4. USS *Olympia* (Cruiser #6)**

**Note:** Navy Department Model catalog #188. Scale 1:48. "Builder's model" by the Bureau of Construction and Repair, USN, ca. 1891. Museums frequently store large artifacts like ship models in wooden crates for extended periods. Today we know that storage crates must be constructed from materials which will not adversely affect the contents. This photograph probably was taken in 1946 and shows the pine crate in which the model resided between 1945 and 1952. U.S. Navy models of this vintage usually were made from a limited list of materials which did not include lead. They have tended to be relatively stable. Here, some features of the model are bright brass, nickel, and copper. NSWCCD Curator's Office photo.
